Citizen Report on Utility Terrain Vehicle (UTV) Hazards
and Urgent Need to Improve Safety and Performance
Standards; and Request for Urgent Efforts To Increase
Yamaha Rhino Safety and Avoid Needless New
Catastrophic Injuries, Amputations and Deaths

**Safety Changes Are Urgently Needed
For The Yamaha Rhino Because It
Has Substantial Designed-In Product
Hazards And Is Associated With
Literally Thousands of Rollovers and
Hundreds of Devastating Injuries,
Including Amputations, Crushes,
Fractures, Acute Compartment
Syndrome, Surgeries, Other
Disabling and Permanent Injuries,
and Dozens of Deaths**

Report Date: February 26, 2009

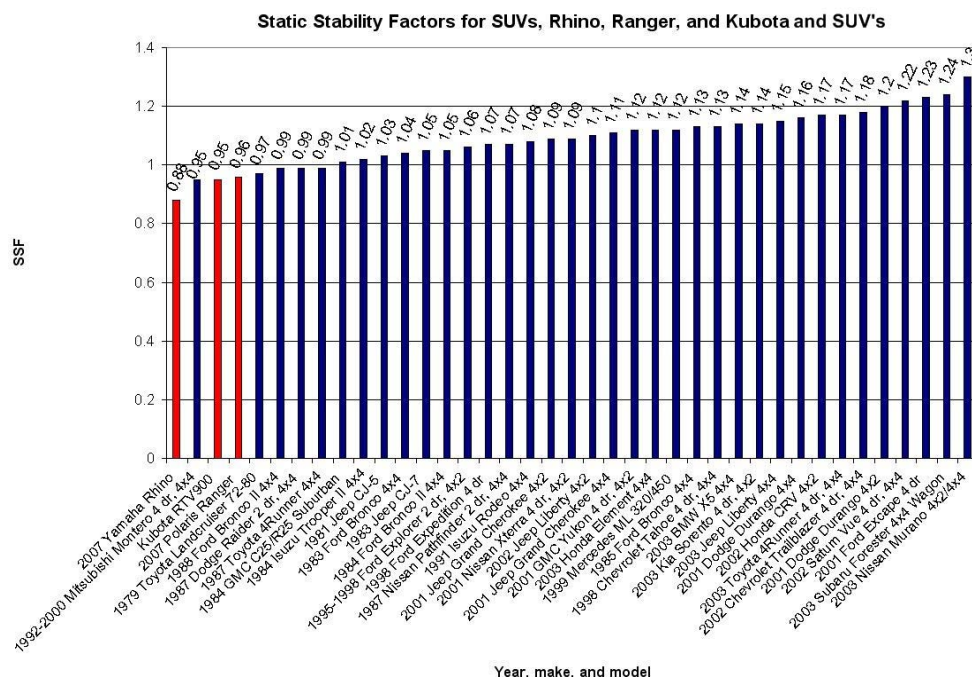
NHTSA determined static stability factor averages for model year 2003 automobiles. The average SSF for 2003 passenger cars is 1.41. It is 1.17 for SUVs; 1.18 for pickup trucks; 1.24 for minivans; and 1.12 for full size vans. Though UTVs such as the Yamaha Rhino might appear truck-like with their cargo bed, side-by-side seating, steering wheel, etc, they are very dangerous because they are extremely unstable, tippiest than almost any other four wheeled vehicle ever made.

SSF of Rhino, Ranger and RTV9000 Plotted with SSFs of SUVs; The Rhino Is One of the Tippiest Vehicles Ever Sold

B. The Rhino's 0.88 SSF Makes It One of the Tippiest 4-Wheeled Vehicles Ever Produced and Distributed

The 0.88 SSF for Yamaha Rhinos is one of the lowest SSF's ever measured, 25% lower than the 1.18 average for 2003 pickup trucks. And unlike trucks, Yamaha Rhinos are sold

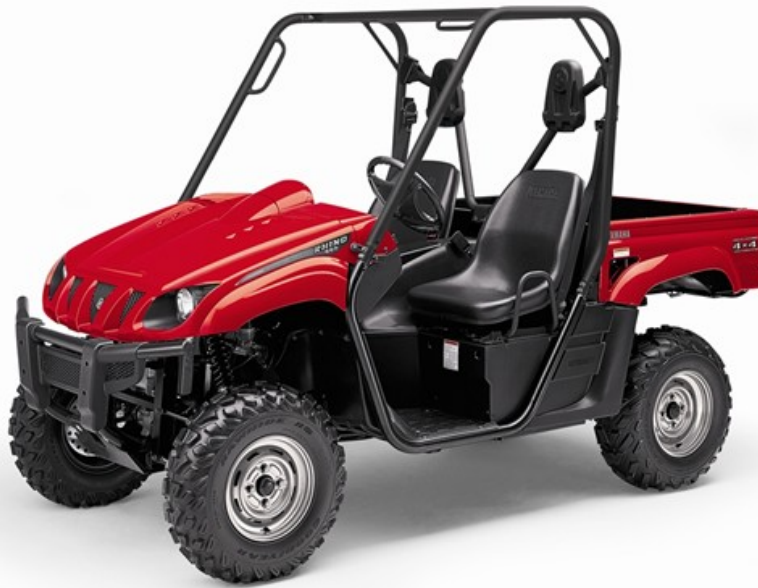
Yamaha Rhino — No occupant containment protection offered until Yamaha announced a half-door retrofit on August 27, 2007 after hundreds of catastrophic leg and foot ejections, and catastrophic related crushes, fractures, amputations and dozens of deaths. Yamaha concedes that half of Rhinos remain without Yamaha's retrofit doors.

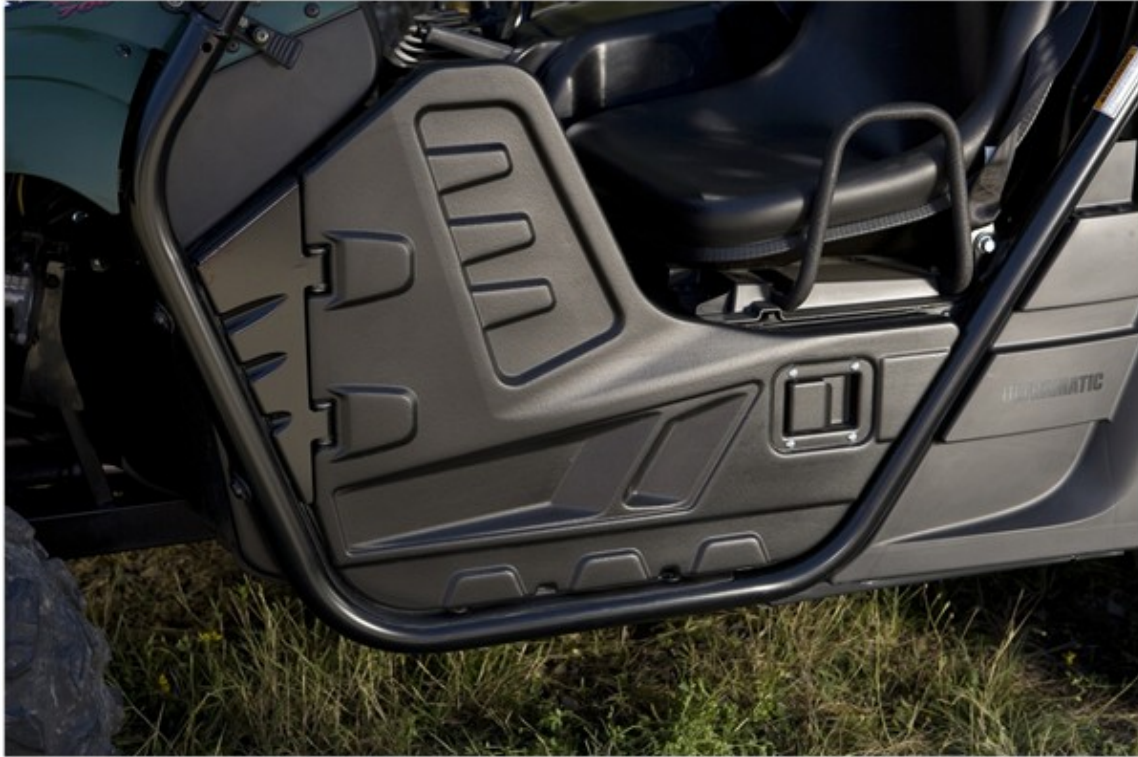
Yamaha Rhino Half Doors. On and after August 27, 2007, Yamaha offered free half door retrofit for all Rhinos ever made because doorless Rhinos had injured and killed many riders. Even with these half doors, however, the Rhino remains a substantial product hazard because it is so unstable, offers no hand and arm protection for drivers, lacks a rear differential, has seat belts that fail to lock in rollovers, and presents other hazards discussed herein.

This report requests that Yamaha, the industry, manufacturers, ROHVA, NHTSA and/or the CPSC immediately disseminate effective notice, through a formal recall and multiple follow up mailings, to the entire population of current Yamaha Rhino owners and shops likely to sell or repair the vehicles, of Yamaha's free door retrofit program, and upgrade and thereby quickly expand the retrofit into a formal recall. Yamaha should also place paid advertising about the free door retrofit in UTV, ATV, dirt bike and off-road magazines.

The Yamaha Rhino half-door should also be upgraded to a full door and/or should be augmented with netting, because Rhino half-doors fail to protect occupant’s hands and arms and are too low to always protect feet and legs.

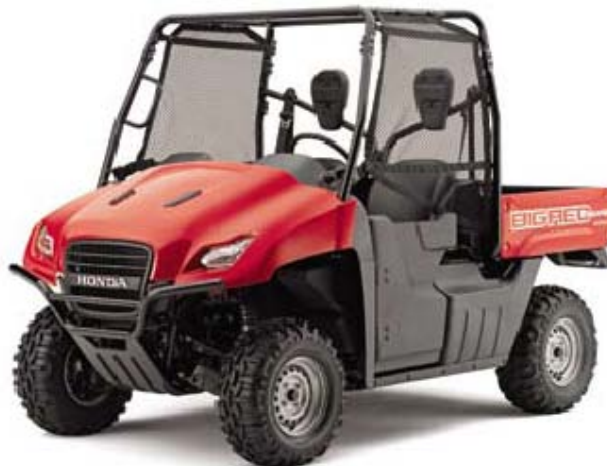
One UTV design with a safety envelope superior to the Rhino is the Honda Big Red which comes factory equipped with full hand and arm protection netting as well as foot and leg protection.⁹

Honda Big Red — Equipped with hand, arm, leg and foot protection.

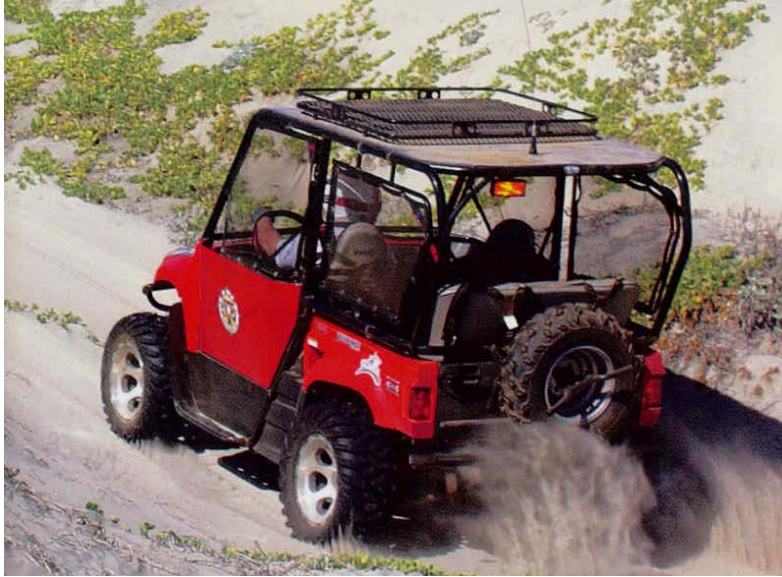
**Baja UTV Tours Outfitter (800-903-1098) –
Full cab doors with polycarbonate windows retrofitted on Rhino.**

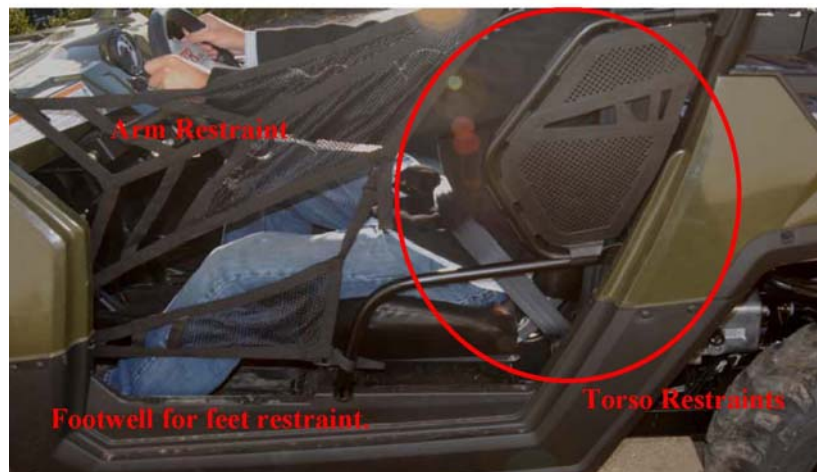
Polaris RZR — Equipped with torso, leg, foot, hand and arm net protection.

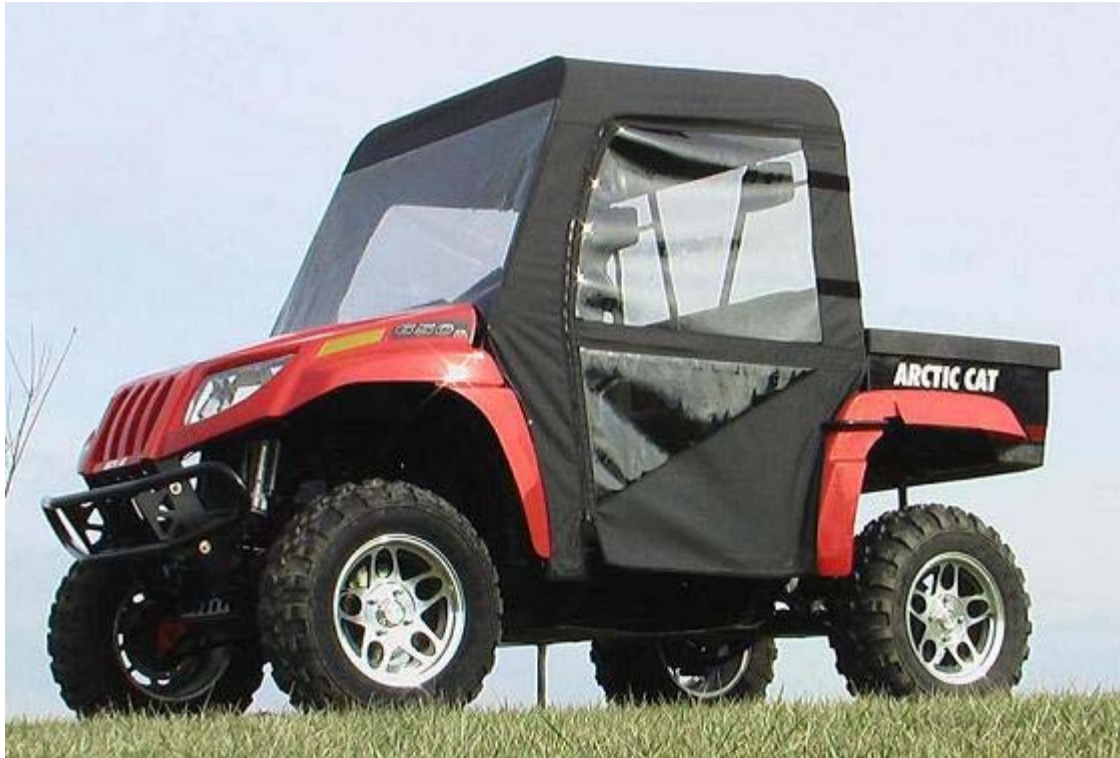
New Model Year 2009 Arctic Cat Prowler 1000, and full cab door option. Unfortunately, the full cab door is not standard and needs to be stronger. Also, it is currently marketed as a “weather” option, not a safety option.

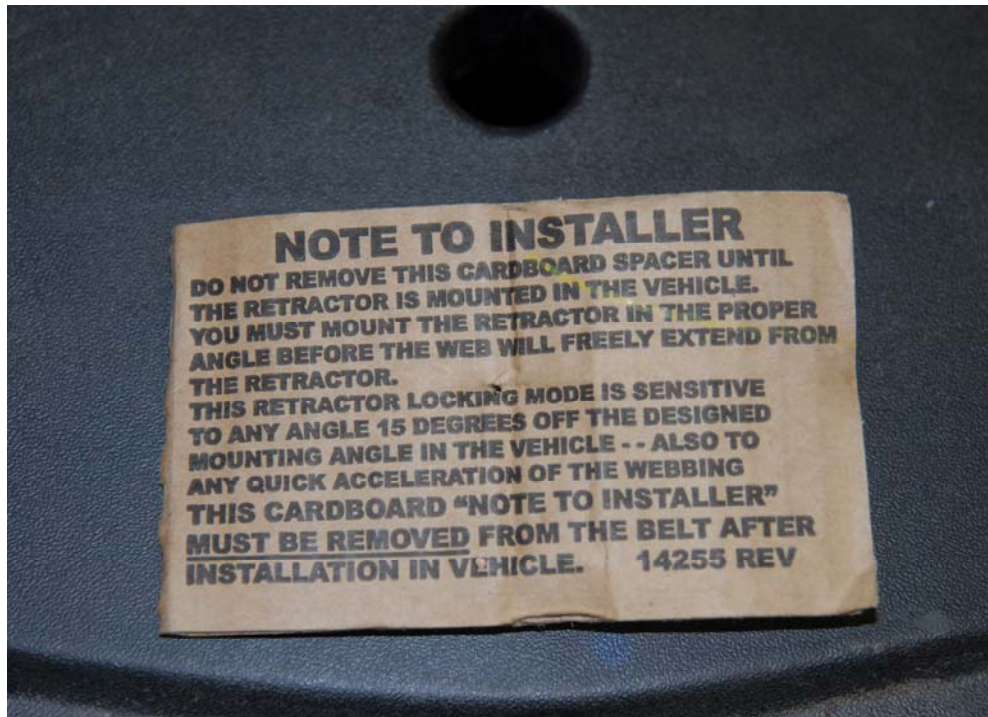
Polaris RZR Seat Belt Instructions [discussing how the Polaris RZR belts locks automatically at 15 degrees or higher lateral angles].

The Polaris RZR, on the other hand, has a retractor that locks at vehicle angles greater than 15 degrees, significantly enhancing protection of vehicle occupants in rollovers.

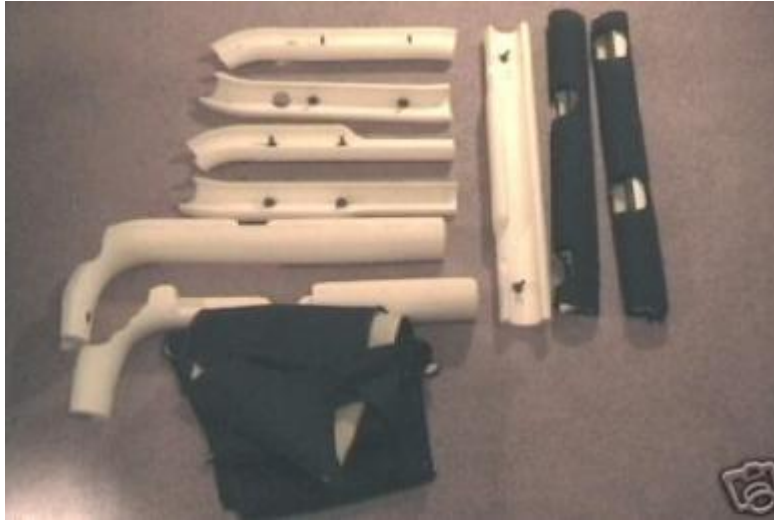
2003 – 2006 JEEP WRANGLER TJ ROLL BAR PADDING

A complete set of original rollbar foam padding and the zippered cloth covers from inside a 2006 Jeep Wrangler.

Jeep Wrangler roll bars have long been padded under FMVSS 201 for head impact protection.

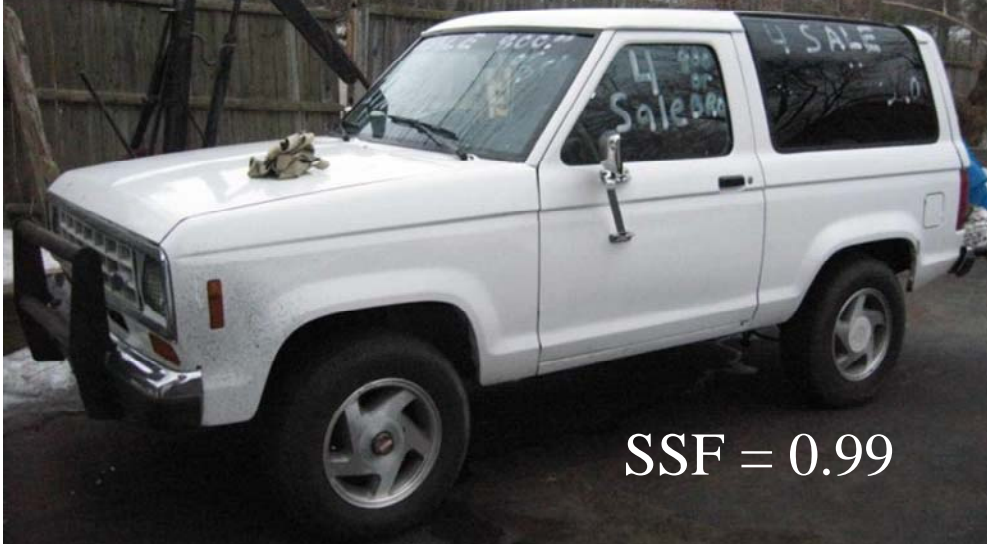
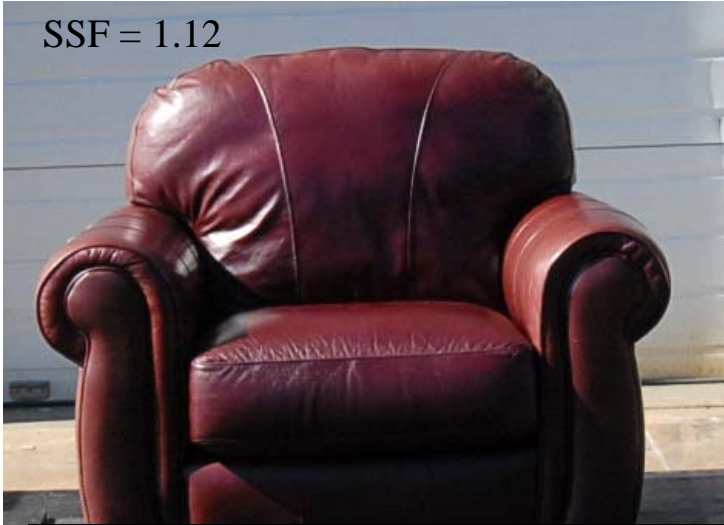
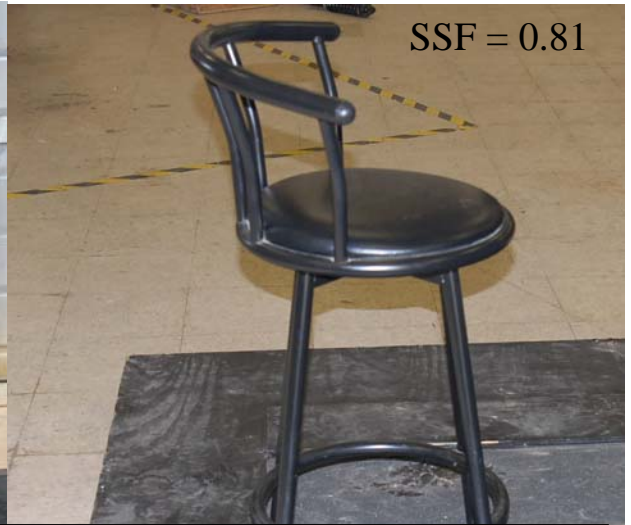
SSF = 1.12

SSF = 0.81

The static stability factor can also indicate the stability of other objects such as chairs and stool seats. A stool is much more “tipsy” than an easy-chair. The static stability factor predicts this with the stool having a much lower static stability factor.

Static Stability Factor can also indicate the stability of other objects such as chairs and stool seats. A stool is much more “tipsy” than an easy-chair. The static stability factor predicts this with the stool having a much lower static stability factor, 0.81, than the lounge chair, 1.12.
